Geological and Geomorphological Factors at some Landslide Areas in Shikoku

FURUYA, Takahiko. Geological and Geomorphological Factors at some Landslide Areas in Shikoku. Bulletin of the Disaster Prevention Research Institute 1976, 26(2): 101-118

By Takahiko FURUYA

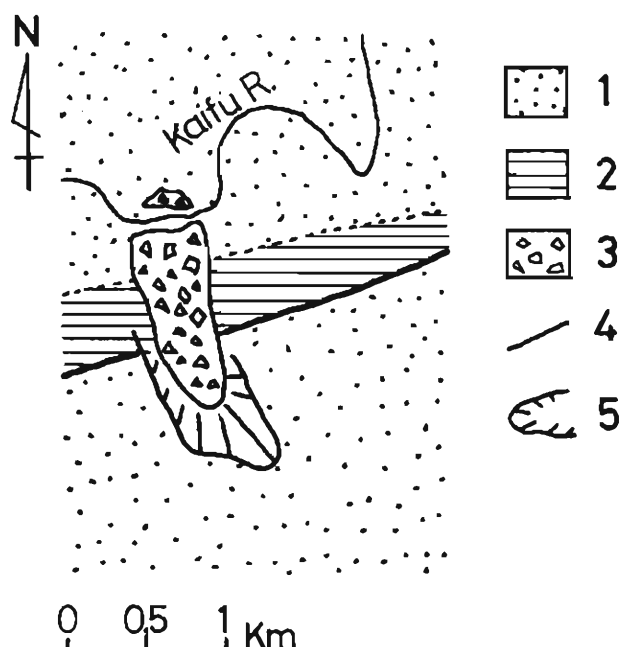
Fig. 2. The geological outline of Hose landslide area.

1: Sandstone rich formation 2: Mudstone rich formation 3: Detrital material deposit 4: Fault line 5: Landslide scarp

The landslide area is geologically composed of the upper Cretaceous Mugi formation of the Shimanto zone. The Mugi formation consists of alternated sandstone and mudstone, but is richer in sandstone. The area of Hose landslide is of sandstone and mudstone layers (Fig. 2). This area is located on the westward extension of Hose — Izari fault line (Tokushima Pref. 1972), and the fault is thought to pass through a mudstone layer at the center of the landslide, as observed from the disturbance of the formation. The strike of the formation is about N 80°E, and the dip about 75°N. The strike and dip of the fault are about N 80°E and 90°N.

The landslide occurred on the north facing slope 550 m above sea level, and spread to the direction of about N 80°E. The main slide scarp was between 500 m and 350 m in height. Collapsed materials were deposited between 350 m and 130 m above sea level on the bank of the Kaifu River. The main scarp is composed of a rock formation which was rid of slide. The east-facing part of the scarp gouged by the landslide, looks like “knife ridge” and the slid materials composed of sandstone and mudstone blocks, are not filled up.

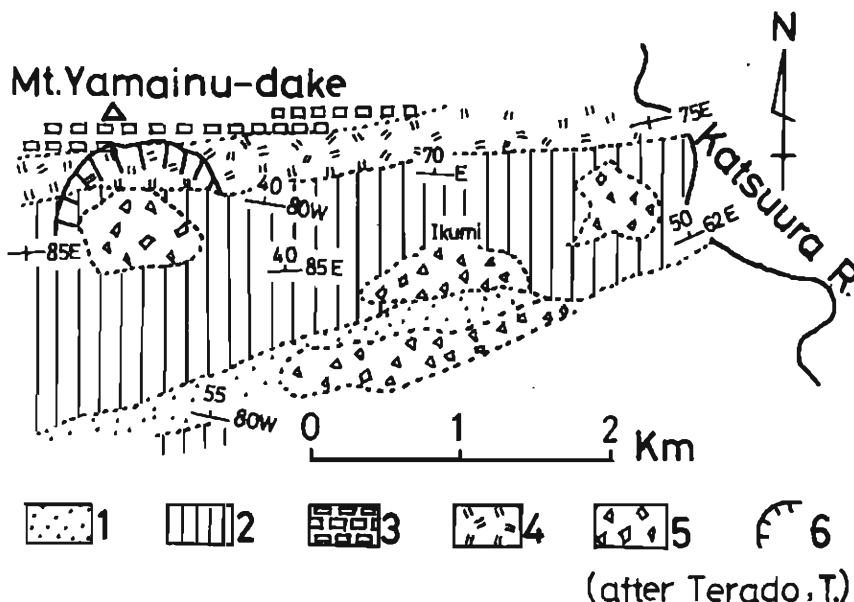
Fig. 3. Geological map of Yamainu-dake landslide area and its environs.

- 1: Sandstone 2: Mudstone 3: Chert 4: Schalstein 5: Detrital material deposit
6: Landslide scarp

This is located on the south facing slope of Mt. Yamainu-dake 1 km west of Ikumi landslide area. It began to collapse after seven days of heavy rain in 1701 (Fig. 3). The landslide scarp, ranging 600 m in width, is horse-shaped opening to the south, and the scarp has the altitude of about 130 m and slopes steeply from 60° to 70°. The western part of the ridge like a “knife ridge”, and it seems that the landslide began at that part (Fig. 3). The detrital deposits named “Tsuka” in front of the landslide scarp are composed of blocks about 5 m in diameter. They have the appearance of a block field. The landslide is about 9.2 ha in area, and the detrital deposits are estimated to be about $2.5 \times 10^6 \text{ m}^3$ in volume. This landslide area is geologically composed of sandstone, mudstone, schalstein, chert, etc, but strike, and from 40°N to 85°N in dip. Prominent fault structure is not recognized in this area. The landslide scarp is mainly composed of schalstein. The crown of the landslide nearly coincides with the boundary between schalstein and chert.

The geological factors of this landslide are thought to be as follows: 1) The first collapse probably began at the opning of the joint plane between chert and schalstein formations by the permiation of groundwater related to heavy rainfall. 2) Deep weathering of rock formations on the ridge of Mt. Yamainu-dake was not so effective to the slide, because the detrital materials are mainly composed of big boulders.

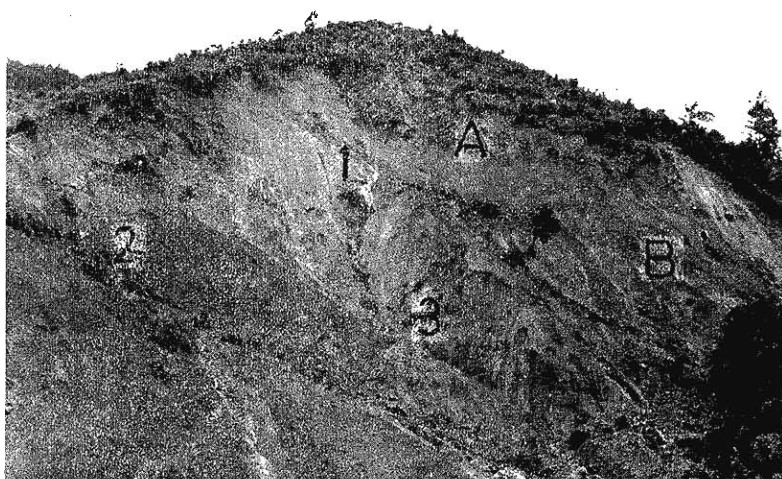
Photo 1. The upper part of Shigeto landslide area.

1~3: Gushed water A: Chert B: Slate

The landslide area is geologically composed of a slate layer and, in places, blocky sandstone layers. The rupture surface cuts the rock formations and is uneven. It is weathered strongly in the upper part, but little in the lower part. No clay is found around the landslide scarp. Much water gushes out of three fissures on the scarp (see photo 1). Detrital materials are deposited at the foot of the scarp, keeping trees tilted on the surface (see photo 2). Around the boundary of rupture surface and slid mass there were many blocks about 50 cm in diameter composed of sandstone and slate. Many cars and people were pushed away to the toe of the landslide, which reached as far as the river (see photo 2). On the basis of these facts, Shigeto landslide may have occurred along weaker fissures inside the rock formations.

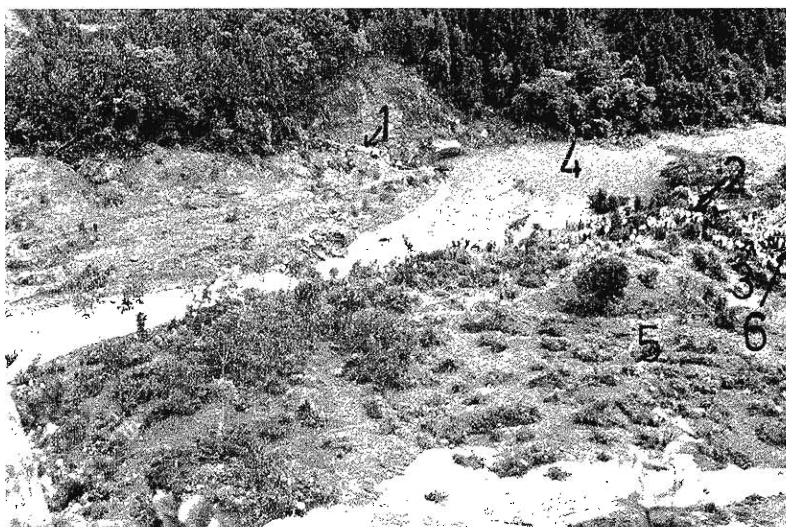
Photo 2. The lower part of Shigeto landslide area.

1: Car 2: Train 3: People 4: The Ananai River 5: Debris 6: Railway

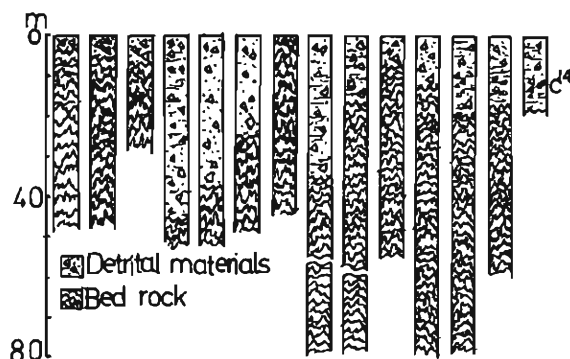
Fig. 4. Geological columnar section at Morito landslide area.

Investigations by means of boring revealed thick detrital material deposits covering the bedrocks (Fig. 4,5). They are mainly composed of angular boulders of basic and pelitic schist supplied from the bedrocks. The openings between angular boulders are filled up with clayed or loamy soil. The depositional structure is composed of debris, clay and loamy soil, which lie side by side in an alternative order, showing the depositional structure of talus deposits. A buried beech gave the radio-carbon date of 15,400 yrs. B. P. (Lin & Yamaguchi, 1970), which was buried at the landslide. Other samples from Taira-shimo landslide area, Tokushima prefecture were dated older than 37,800 yrs. B. P. (N-1652, N-1692).

The detrital material deposits are distributed as in Fig. 4, which shows the subsurface structure clearly. The Morito landslide is active in part at the detrital materials. Especially, there was marked activity from 1953 to at the outlet of the valley which

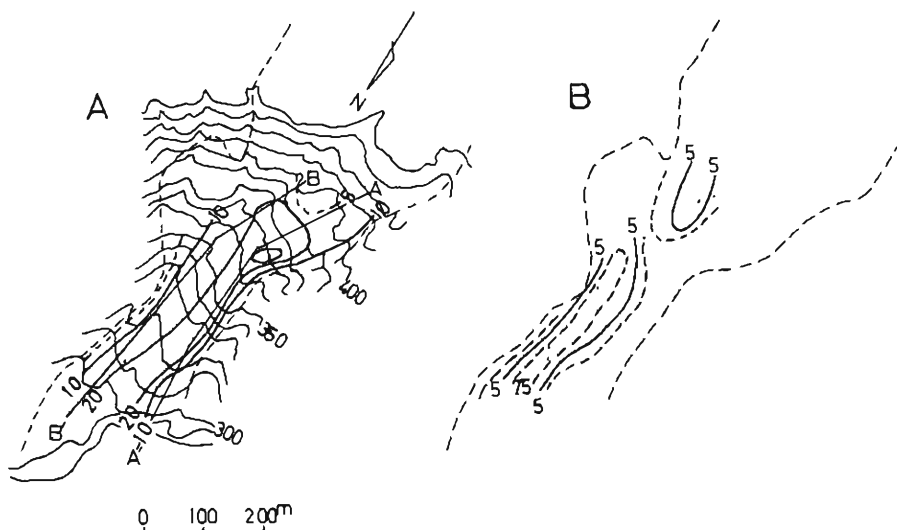
Fig. 6. Subsurface landform at Choja landslide area.

A: Buried bedrock surface by detrital materials B: Buried topographical surface by detrital materials derived from serpentinite A—A, B—B show the locations of geological profile showing Fig. 5.

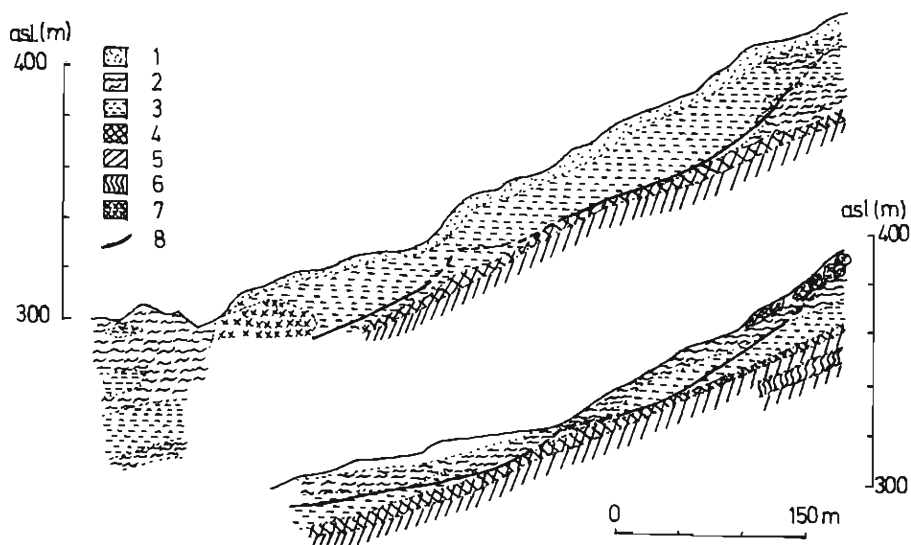
Fig. 7. Geological profile at Choja landslide area (after Kochi Pref., 1972).

1: Surface soil 2: Debris mainly derived from serpentinite 3: Debris mainly derived from slate 4: Weathered slate 5: Slate 6: Serpentinite 7: Mitaki plutonic rocks 8: Presumed slide surface

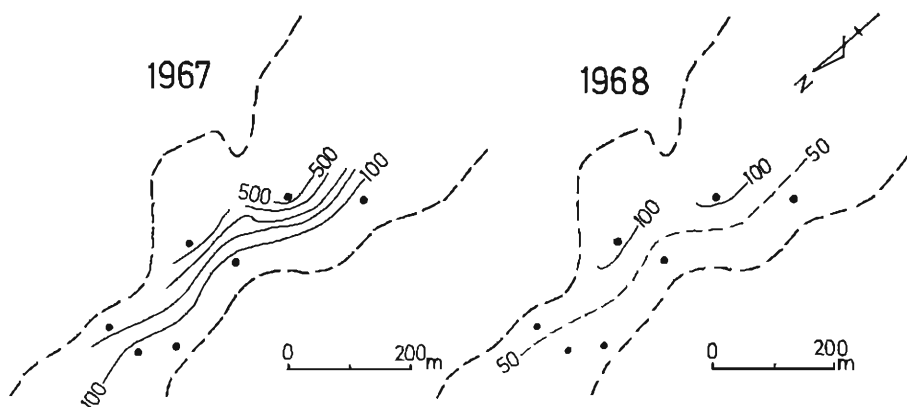
Fig. 8. Distribution of mean drained groundwater in 1967 and 1968 values are shown by l/min .

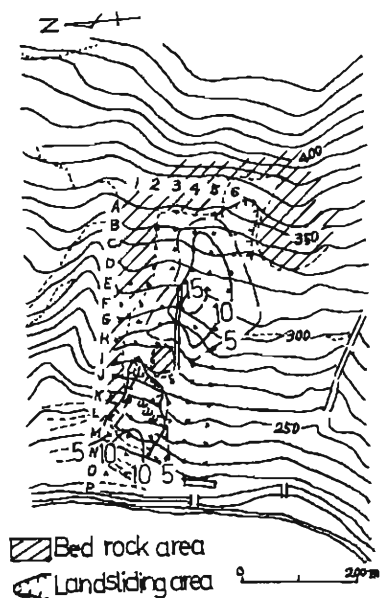
Fig. 9. The map showing a buried topographical surface, measured point of electric prospecting, and active landslide area.

This is a potential landslide area. When farming road was enlarged in 1968, a small landslide occurred at the lower part of the area. The geological investigation by means of drilling, electric prospecting and surface observation brought the following results. Electric prospecting detected a valley-like irregularity under the detrital material by showing a low value of specific resistance (Fig. 9, 10). As a result of boring and field investigations, a subsurface valley buried under the ground is expected. The active landslide is situated at the outlet of the subsurface valley and the slip surface is supposed to exist around the boundary between the bedrocks of pelitic schist and the detrital material deposits. Moreover, the percolation of ground water is observed under the main scarp at the upper end of the moving mass, hence the moving mass seems to be highly water soaked. As above, landslide activities seem to be related to detrital material, subsurface valley and groundwater.

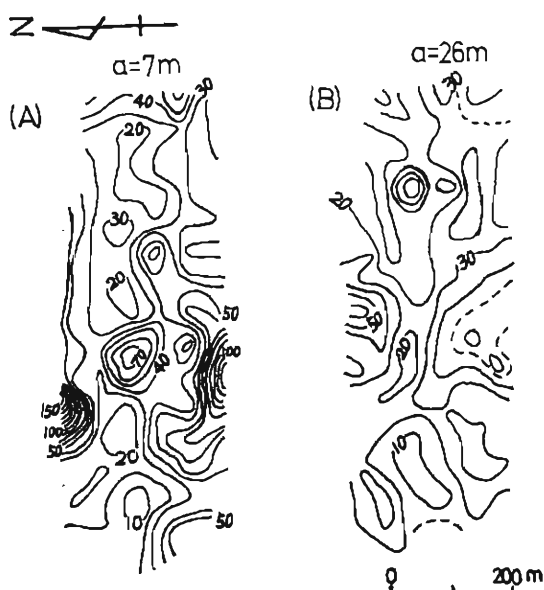
Fig. 10. The Distribution map of apparent resistivity values at Kuraishi landslide area. The map showing the distribution of apparent resistivity values of seven and twenty six meter in depth.

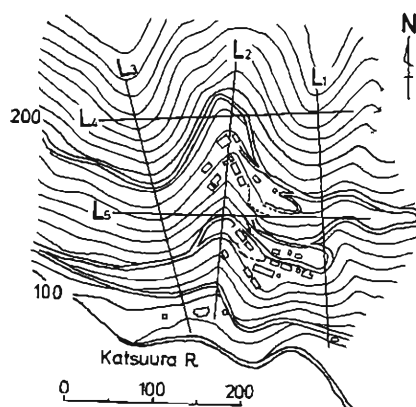
Fig. 11. The map showing the topography of Hiura (Iitani-cho) landslide area $L_1 - L_5$: Measuring lines of seismic prospecting.

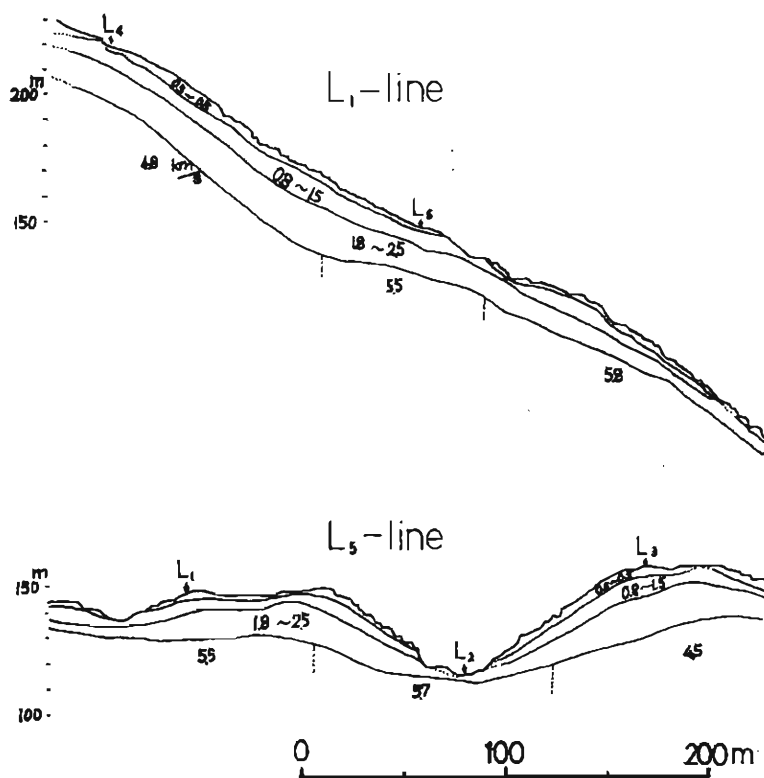
Fig. 12. Underground profile by seismic prospecting at Hiura (Iitani-cho) landslide area. Measuring lines are shown in Fig. 11. (after Tokushima Pref., 1973).

This landslide area is located at the left bank of the Hiura River, a tributary flowing into the Katsuura River. The drainage basin is geologically composed of sandstone, mudstone and diabase, which belong to the Chichibu zone, and the area is covered with detrital materials. The seismic prospecting distinguished four kinds of layers with seismic wave velocities of 0.3~0.6 km/sec, 0.8~1.5 km/sec, 1.8~2.5 km/sec and 3.8~5.8 km/sec (Fig. 11, 12). The low velocity layers of 0.3~2.5 km/sec are in

general detrital materials and weathered layers. The high velocity layers of 3.8~5.8 km/sec are hard bedrock based on these facts and possibility of landslide, the layers are divided into two groups: low velocity group (0.3~2.5 km/sec) and high velocity group (3.8~5.8 km/sec). By careful examination of underground structure down to the bedrock debris or weathered bedrock are certain to the depth of 30 m, sometimes of 60 m. The surface features such as convexity of ridge-like are related only to low velocity layers not to bedrock.

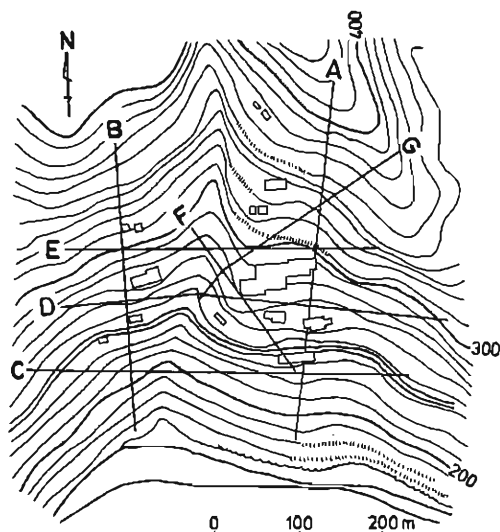
Fig. 13. The map showing the topography of Hiura (Kamikatsu-cho) landslide area
A — G: Measuring lines of seismic prospecting.

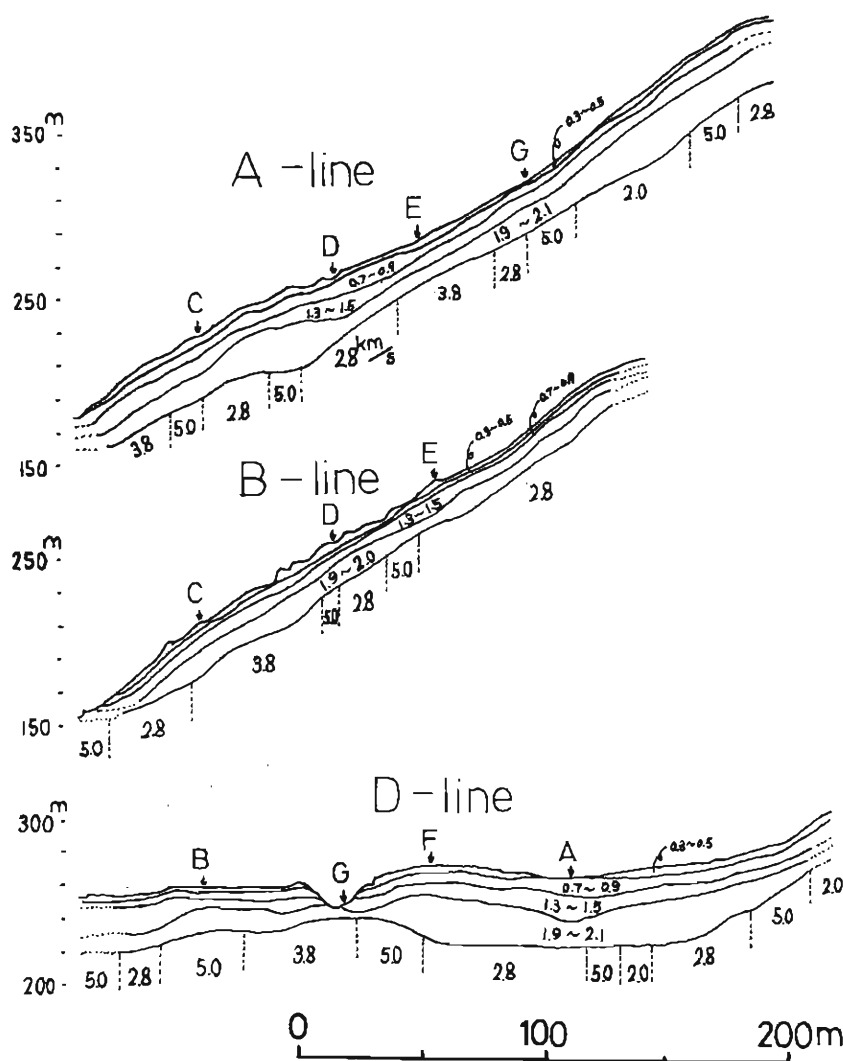
Fig. 14. Underground profile by seismic prospecting at Hiura (Kamikatsu-cho) landslide area. Measuring lines are shown Fig. 11. (after Tokushima pref., 1973).

Underground layers are divided through the seismic prospecting into three: detrital material (0.3~0.5 km/sec), heavily weathered bedrock (1.9~2.1 km/sec) and unweathered bedrock (3.7~5.1 km/sec) (Fig. 13, 14). The last one is stable and on the average 30 m~40 m in depth. The surface features are related to the low velocity layer, which is thinner at the valley and thicker at the ridge. It noteworthy

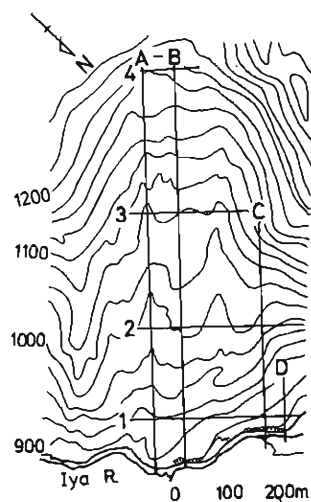
Fig. 15. The map showing the topography of Tairadani landslide area.
A — D, 1 — 4: Measuring lines of seismic prospecting.

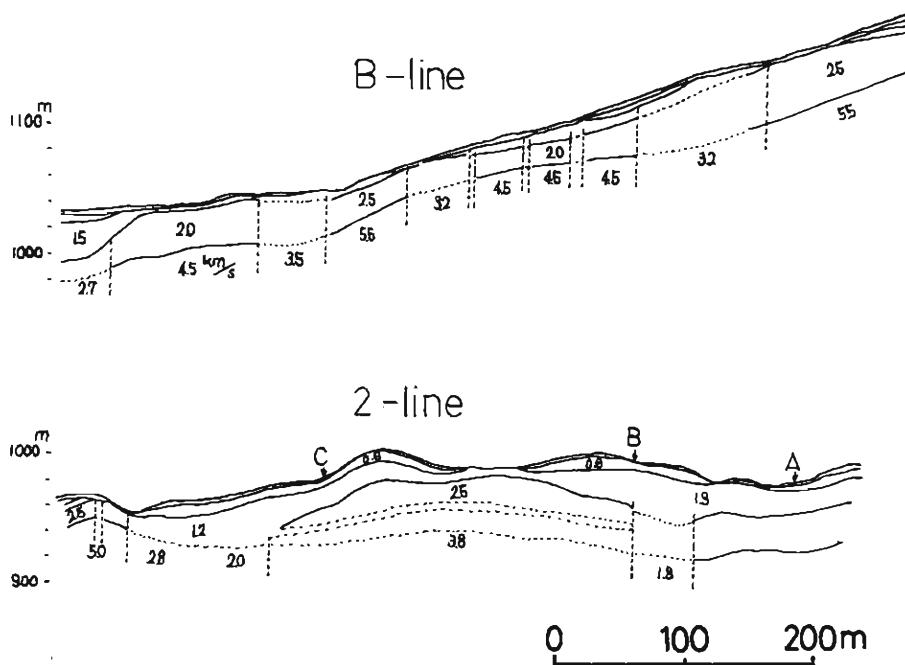
Fig. 16. Underground profile by seismic prospecting at Tairadani landslide area. Measuring lines are shown Fig. 13. (after the Forestry Agency 1965).

Seismic prospecting gave five layers: surfacial soil (0.3 km/sec), detrital material (0.6 km/sec), wet detrital or upper weathered layer (1.0~1.5 km/sec), lower weathered layer (2.0~2.5 km/sec) and unweathered bedrock (4.5~5.5 km/sec) (Fig. 15, 16). The layers between 0.3~2.5 km/sec, which seem to be related to landslide is 20 m to 50 m thick in general, however it measures 70 m at the thickest and rather thinner at the valley. The seismic wave velocity of 2~3.2 km/sec observed at many points within bedrock may indicate shattered or fractured zones.

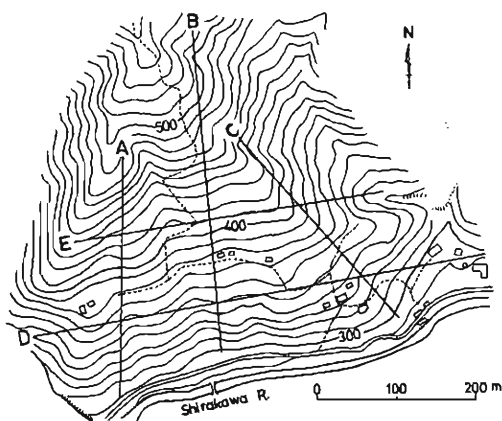
Fig. 17. The map showing the topography of Shirakawa landslide area. A — E: Measuring lines of seismic prospecting.

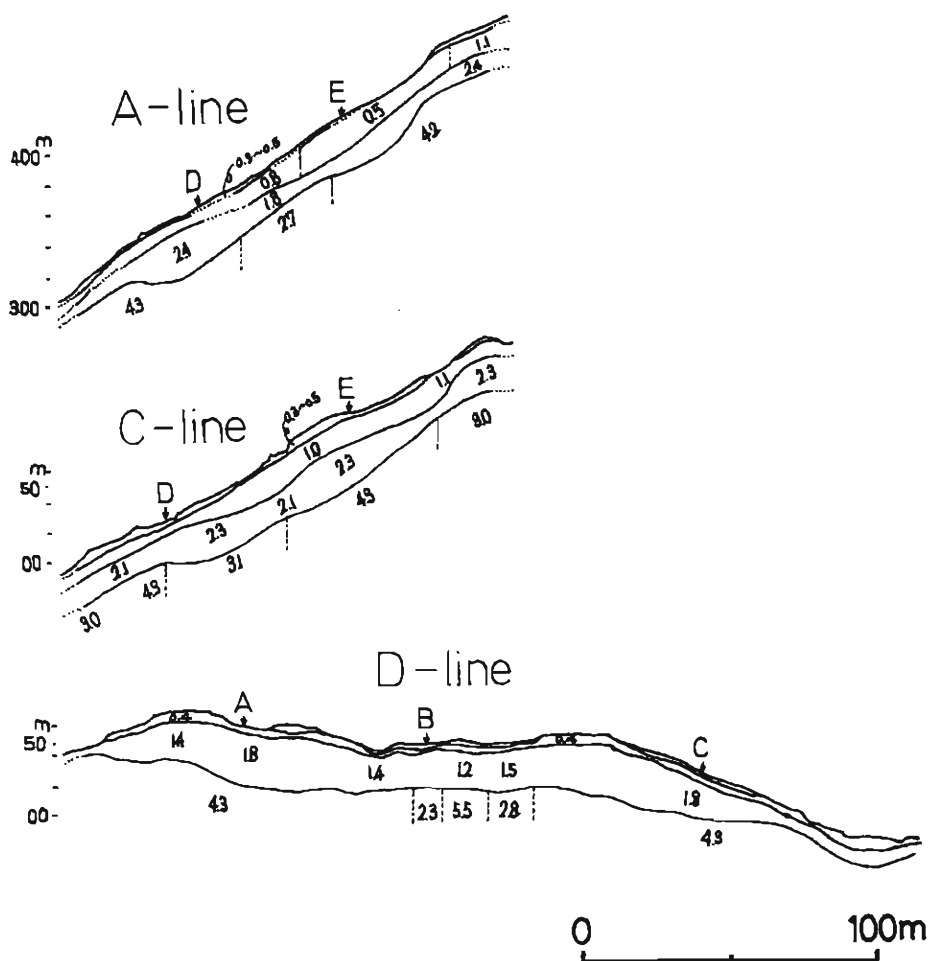
Fig. 18. Underground profile by seismic prospecting at Shirakawa landslide area. Measuring lines are shown in Fig. 15. (after Tokushima Pref., 1972).

The underground structure is divided into four layers with seismic wave velocities of 0.2~0.4 km/sec, 0.4~1.2 km/sec, 1.2~3 km/sec and 3~5.5 km/sec (Fig. 17, 18).

That last one is expected to be the bedrock but it is rather thin around the valley. The wave velocity in detrital material measures somewhat lower. Both detrital material and weathered layer are common in low wave velocities and were hardly distinguishable. The low velocity layer extends as far as the ridge line and the mountain top, which is not covered with detrital material, and which seems to have a thick weathered layer. Therefore, there is no great difference in landslide possibility between the slope covered with detrital material and the slope covered with detrital material and the ridge and mountain top thickly weathered.

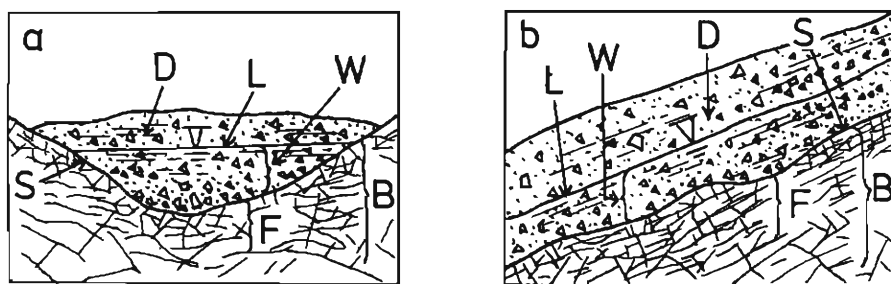
Fig. 19 a, b. Schematic profile of the hydrogeology of the landslide area composing of the detrital material deposits. B: Bedrock D: Detrital material deposit S: Subsurface landform L: Groundwater level (appearance) W: Water-bearing bundle F: Fissure water

Thus, according to bedrock formation or detrital material deposits, different process and different velocity may be expected for landslide occurrence. The relationship between geology and groundwater for landslide occurrence is schematically shown in Fig. 19a, b.
